Myers Engineering, LLC

November 1, 2014

This letter is a report of my findings and recommendations concerning the Single Family Residence located on Kitsap County Park property at 19235 NW Stavis Bay Road in Seabeck, WA. The residence is a post & beam wood frame structure supported on treated wood pilings laid out in a grid 10ft o.c., with the exception of pilings along the southern edge of the deck which are 12ft from the adjoining line of pilings. A layout with gridlines for reference has been included (Image 1). When you contacted me in August you asked that I visit the site and make an assessment of the existing deck framing and 1 or 2 of the support piles for the residence. On September 8th I was able to visit the site where I met with the current tenant, Brian Bailey. Brian was able to show me around and point out the pilings that were of concern.

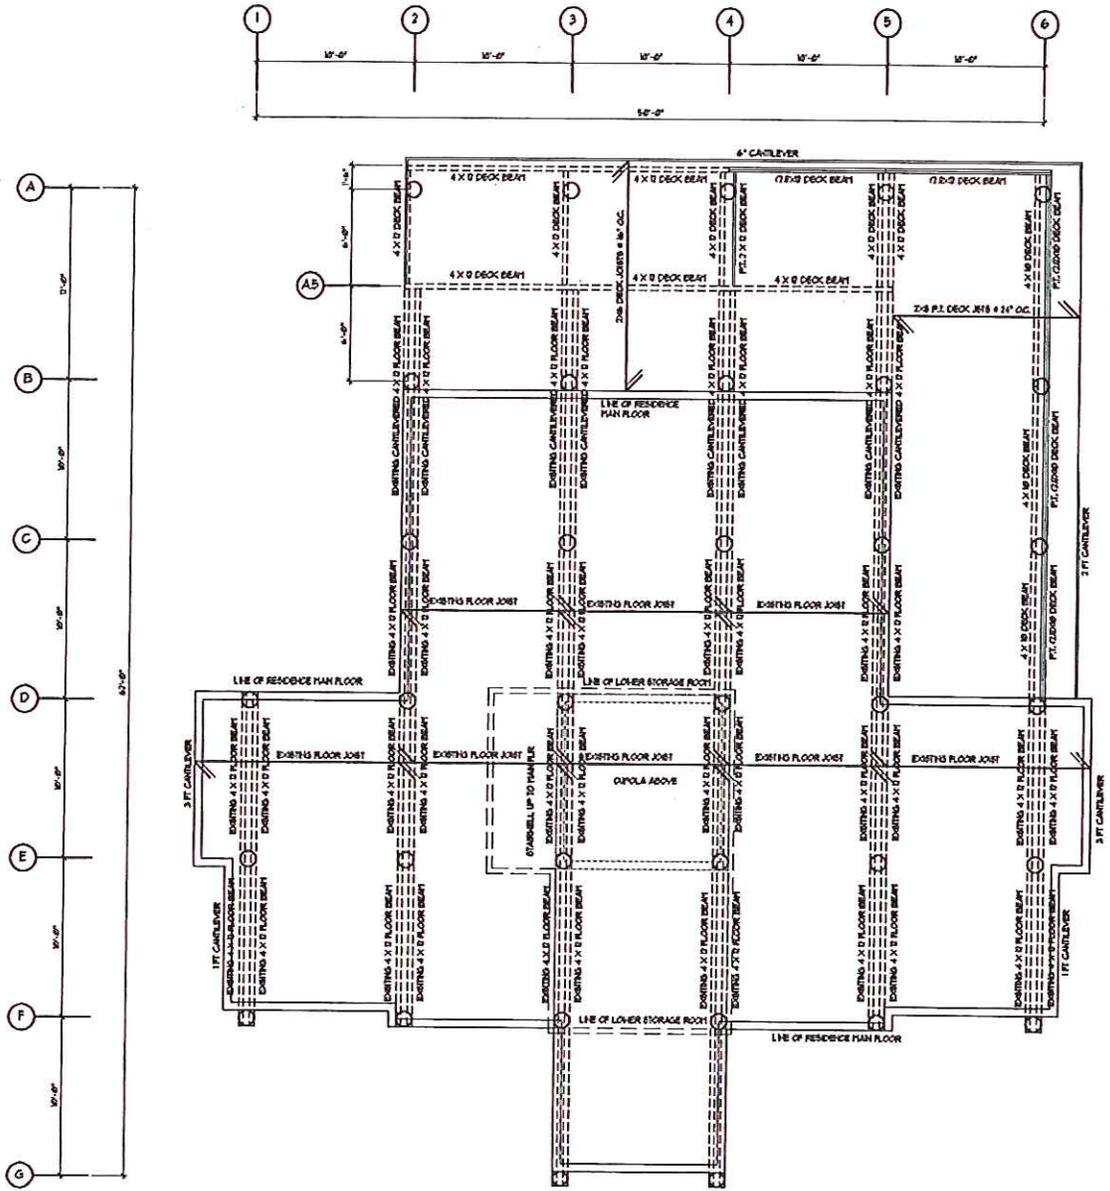
Image 1

The deck is located on the southern end of the building and wraps part way around the west side. There are two distinct areas of framing. The first area is located between gridlines A & B and extends from gridline 2 to gridline 5. This portion of the deck is partially supported by pairs of cantilevered 4x12 beams extending 6ft past the pilings of gridline B to gridline A.5. A 4x12 beam is attached to the ends of these cantilever beams with conventional light gage steel hangers (Image 2). This 4x12 supports additional 4x12 beams that span the last 6ft to the pilings at gridline A and cantilever out an additional 18 inches where they support another 4x12 beam from gridline 2 to gridline 4 and a (2)2x12 beam between gridlines 4 & 5. This beam and the one located at gridlines A.5 support 2x6 deck framing at 16" o.c. that spans from a ledger at gridline B to 2ft past gridline A. This results in the joists cantilevering 6" past the last beams. The 4x12 beams that cantilever out from under the main floor of the residence appear to be in good shape. However, the 4x12 located at Gridline A.5 has some soft spots when probed with a scratch awl. The beams that extend from gridline A.5 out past the pilings at gridline A also have rot damage, and the connections to the last beams are failing as a result. In fact the connection at the southeast corner, nearest to piling 2A, has completely failed (Image 3). This has caused the beam to deflect downward putting additional stress on the connection closest to piling 3A. This connection has begun to fail from the stress and the presence of rot in the supporting beam (Image 4). The connection closest to the piling at 4A is also beginning to fail as a result of rot in the supporting beam (Images 5 & 6). The tenant has roped off the southeast corner of the deck above to prevent access, and limit the impact of any additional live load.

I recommend the careful de-construction and rebuilding of the existing deck. When the existing decking surface is removed, the tops of all beams should be checked for any decay that was not observable at the time of my visit. All of the damaged or rotting beams or joists should be replaced with identical new pressure treated material. The new 4x12 beam at gridline A.5 should be hung from the cantilevered house 4x12's with inverted Simpson HU412 or HUC412 hangers. The new 4x12's that extend from gridline A.5 to cantilever over the piling along gridline A should be attached to the 4x12 at gridline A.5 with Simpson HU412 hangers in standard orientation. The new exterior 4x12 beam at exterior edge of the deck framing should be hung from the cantilever 4x12's using inverted HU412 hangers. Additionally, I also recommend that the connections of all existing ledgers be supplemented by the use of Simpson SDWS or SDWH wood screws at least 3" long staggered @ 12" o.c.

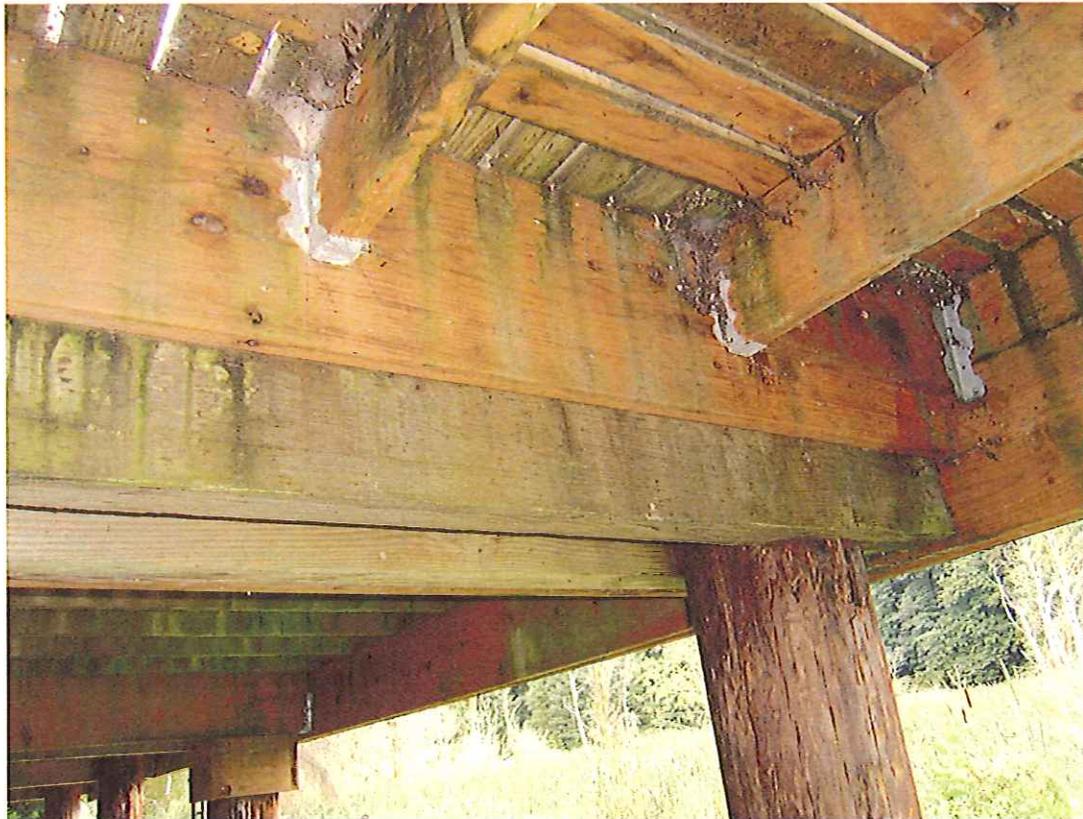
Image 7

The second area of deck is located between gridlines 5 & 6, and extends from gridline A to gridline D. This area is framed with 2x8 deck joists @ 24" o.c. that are supported by a ledger at gridline 5 (Image 7) and cantilever 2ft past beams located at gridline 6 (Image 8). The ledger at gridline 5 is nailed in place. Current codes would require the use of lag screws or thru-bolts to avoid the loading of nails in withdrawal during a seismic event or some other cyclic live load. The beams at gridline 6 consist of 4x10's on the inside face of the pilings and (2)2x10 beams on the outside face. The 4x10's have some rot when

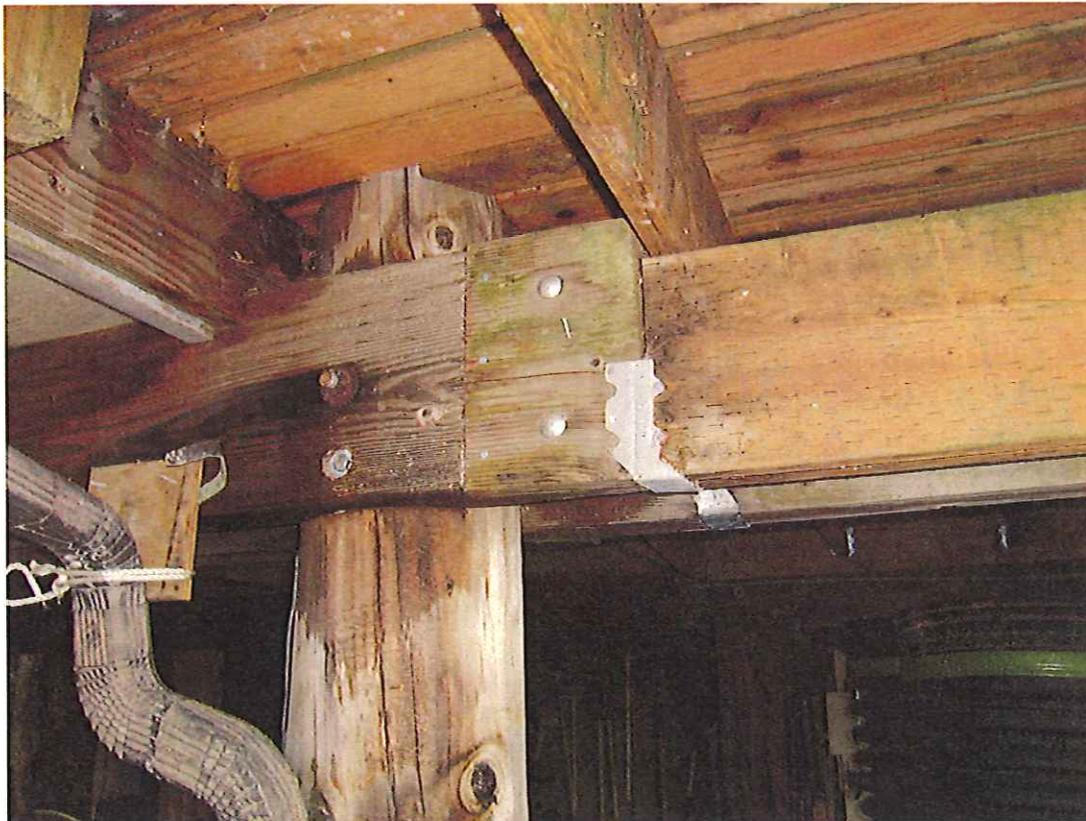
Image 9

probed with a scratch awl, and when tapped sound hollow indicating there may be extensive rot in the interior core of the beam. Additionally, deck beams are spliced to the ends of 4x12 beams supporting the house at piling 6D (Images 9 & 10). While this connection does not appear to be in distress, it can be described as non-standard at best.

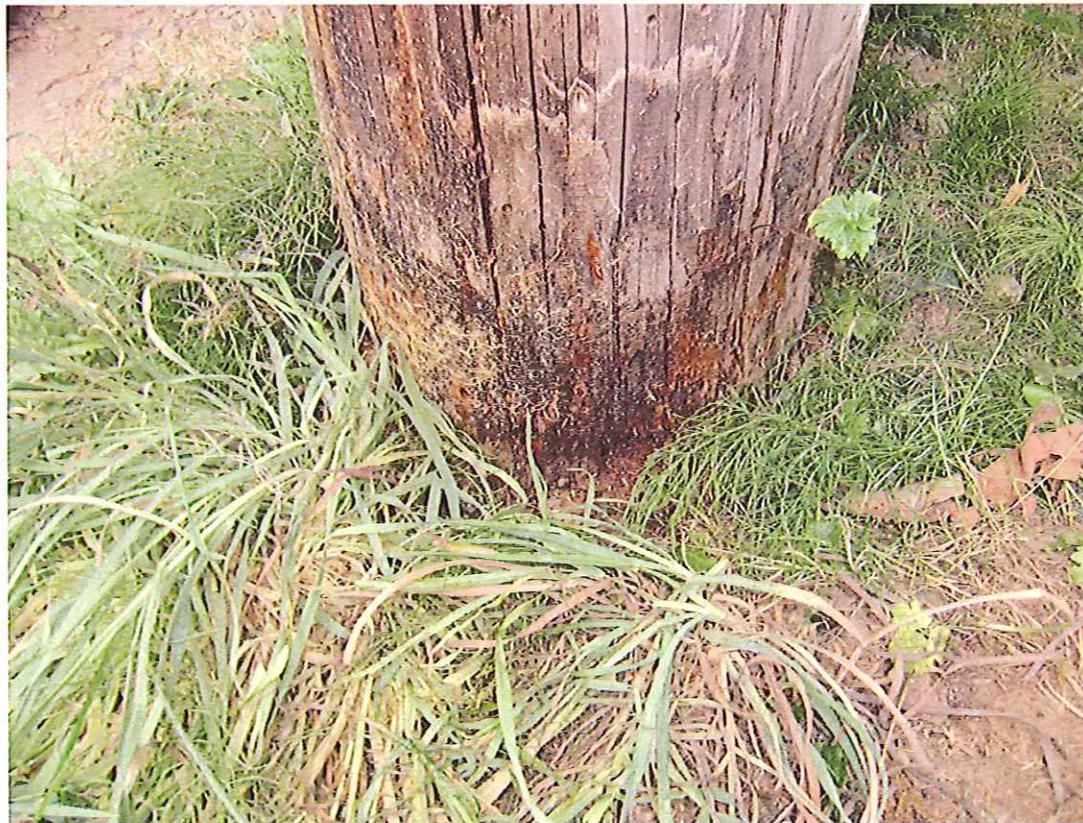
Image 11

The support pilings for the residence consisted of treated wood poles with tapered profiles. The piling diameters were approximately 14 inches at ground level. The majority of the pilings observed were in good shape. Three of the piling had some damage at their base at ground level. Piling 1D had minor insect damage at ground level. Piling 5C has some minor damage at ground level of an undetermined origin. Piling 2C (Image 11) was the worst of the three, and had an area of insect damage approximately 2 inches square at the surface and extending 3 to 4 inches into the piling. At the time of my visit, a pest control specialist was on site to apply insect spray to the pilings in order to eliminate any ongoing infestations.

At this time I do not recommend the need for repairs to any of the pilings. However, all of the pilings should be monitored to ensure there are not any new infestations of insects. I recommend that the size and locations of the vertical cracks in the above mentioned pilings be documented. If the cracks worsen, or new cracks appear following any new seismic activity, the pilings should be evaluated by a design professional specializing in the repair of wood pilings or utility poles.

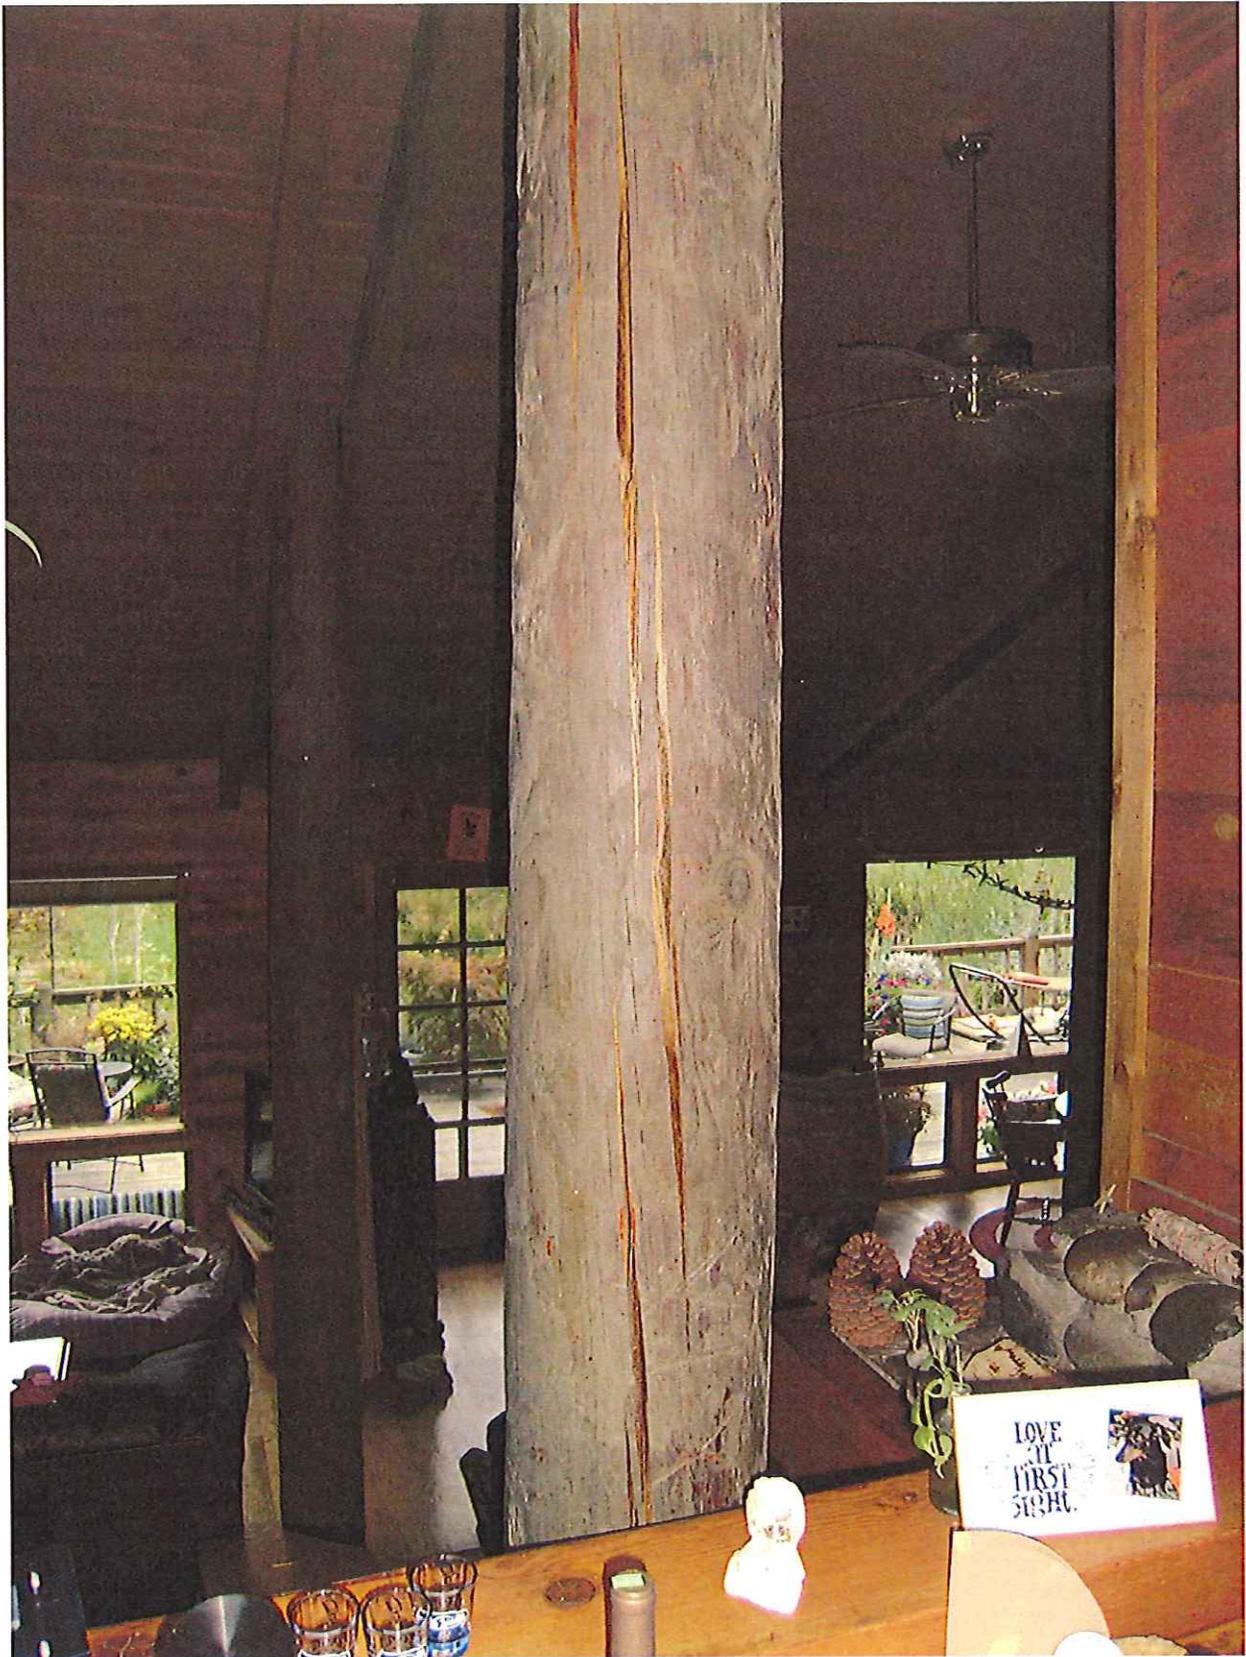
Image 12

While I was on site Brian Bailey showed me some of the piling inside the residence that he was concerned about. The pilings 1E, 1F, 3B, 3C, 3D, 3F, 4C, 5C, 5D, & 6D all had vertical cracks along the grain lines (Images 12 thru 16). The cracks varied in width, with some as wide as 1 inch at the surface. According to Brian, the cracks had primarily appeared after the Nisqually earthquake in 2001. These cracks, while aesthetically unpleasant, do not appear to have affected the ability of the pilings to support the weight of the structure. No damage was observed that may have compromised any of the beam to post connections.
