Hazardous Material Survey Report Addendum

ORION Project O15-0211
CC: Angela Todd, OES

RE: Hazardous Material Survey Report - Addendum
Kola Kole School
11128 NE Maine Street
Kingston, WA 98346

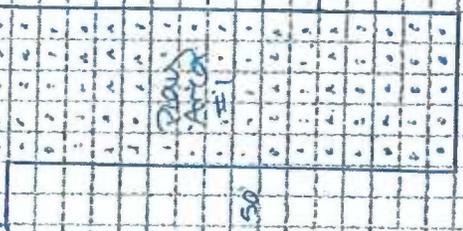
Remediation
Drawings

Based on the lead concentrations of the soils collected on May 7, 2015 and October 8, 2015, it is determined that the soils in Play Area 3, Play Area 1, and the west side of the building starting at the staircase and extending south must be remediated. It is recommended that the top 6 inches of soil in these areas are removed, for a total estimated quantity of 622 cubic feet, and replaced with a clean material. The quantity of soil to be removed can be reduced if these areas are fenced off, paved or are otherwise made inaccessible to children. See Appendix A for a drawing of the remediation area. See Appendix C for photographs.

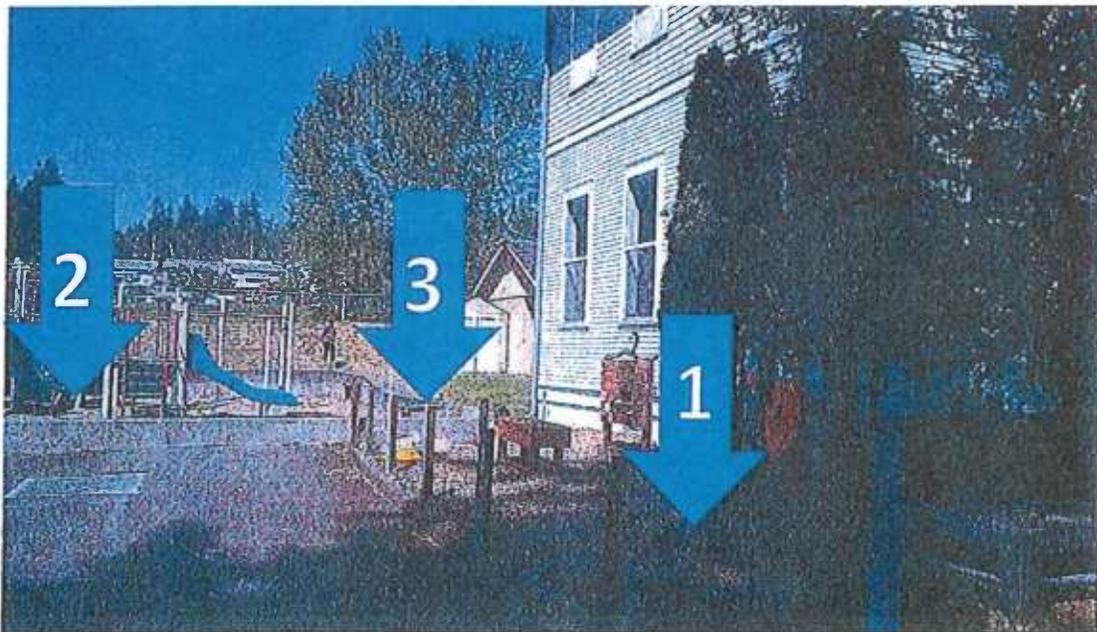
Play Area 1 on the Far Right, Play Area 2 to the Far Left. Play Area 3 just on the other side of the foundation wall (see Appendix A for dimensions)

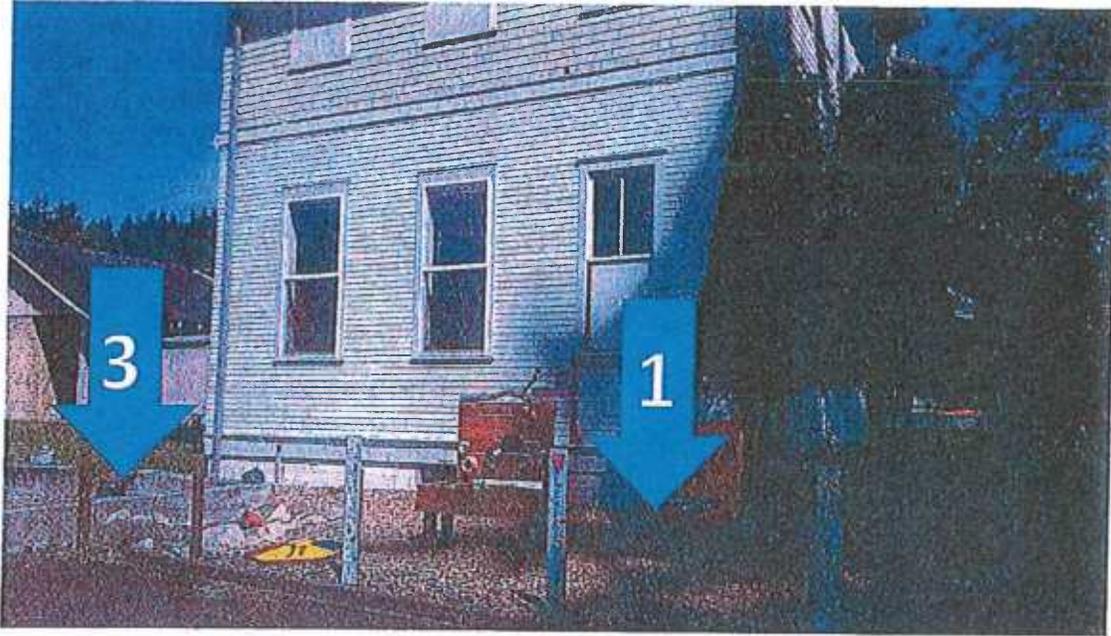
Play Area 1 and 3

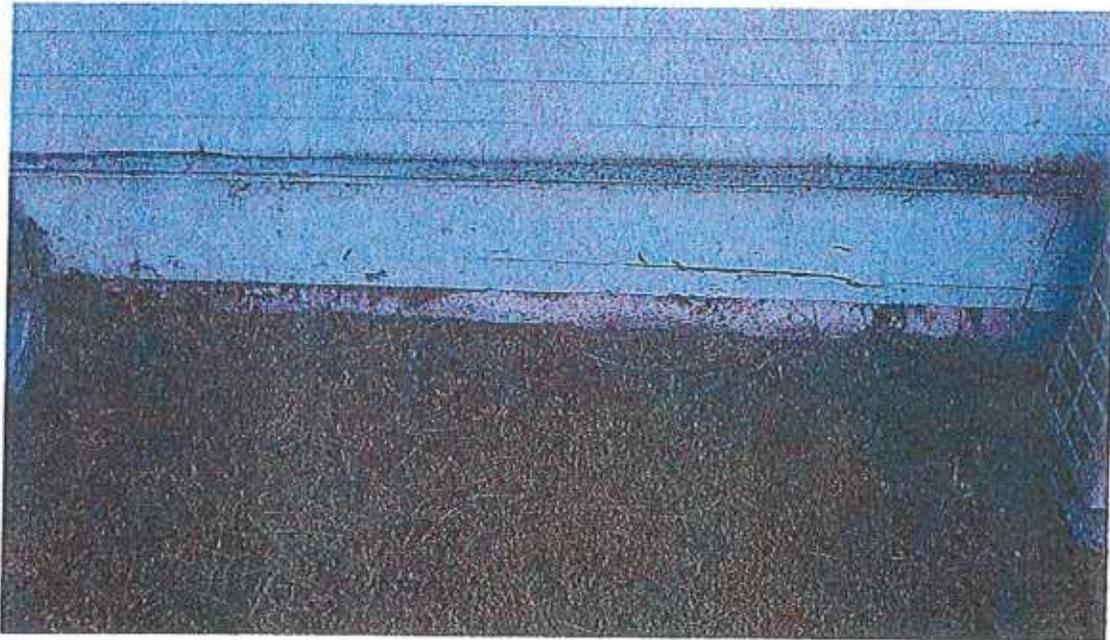
Composite Sample 2 on West Side of Building at Drip Line: bare soil only at base of building

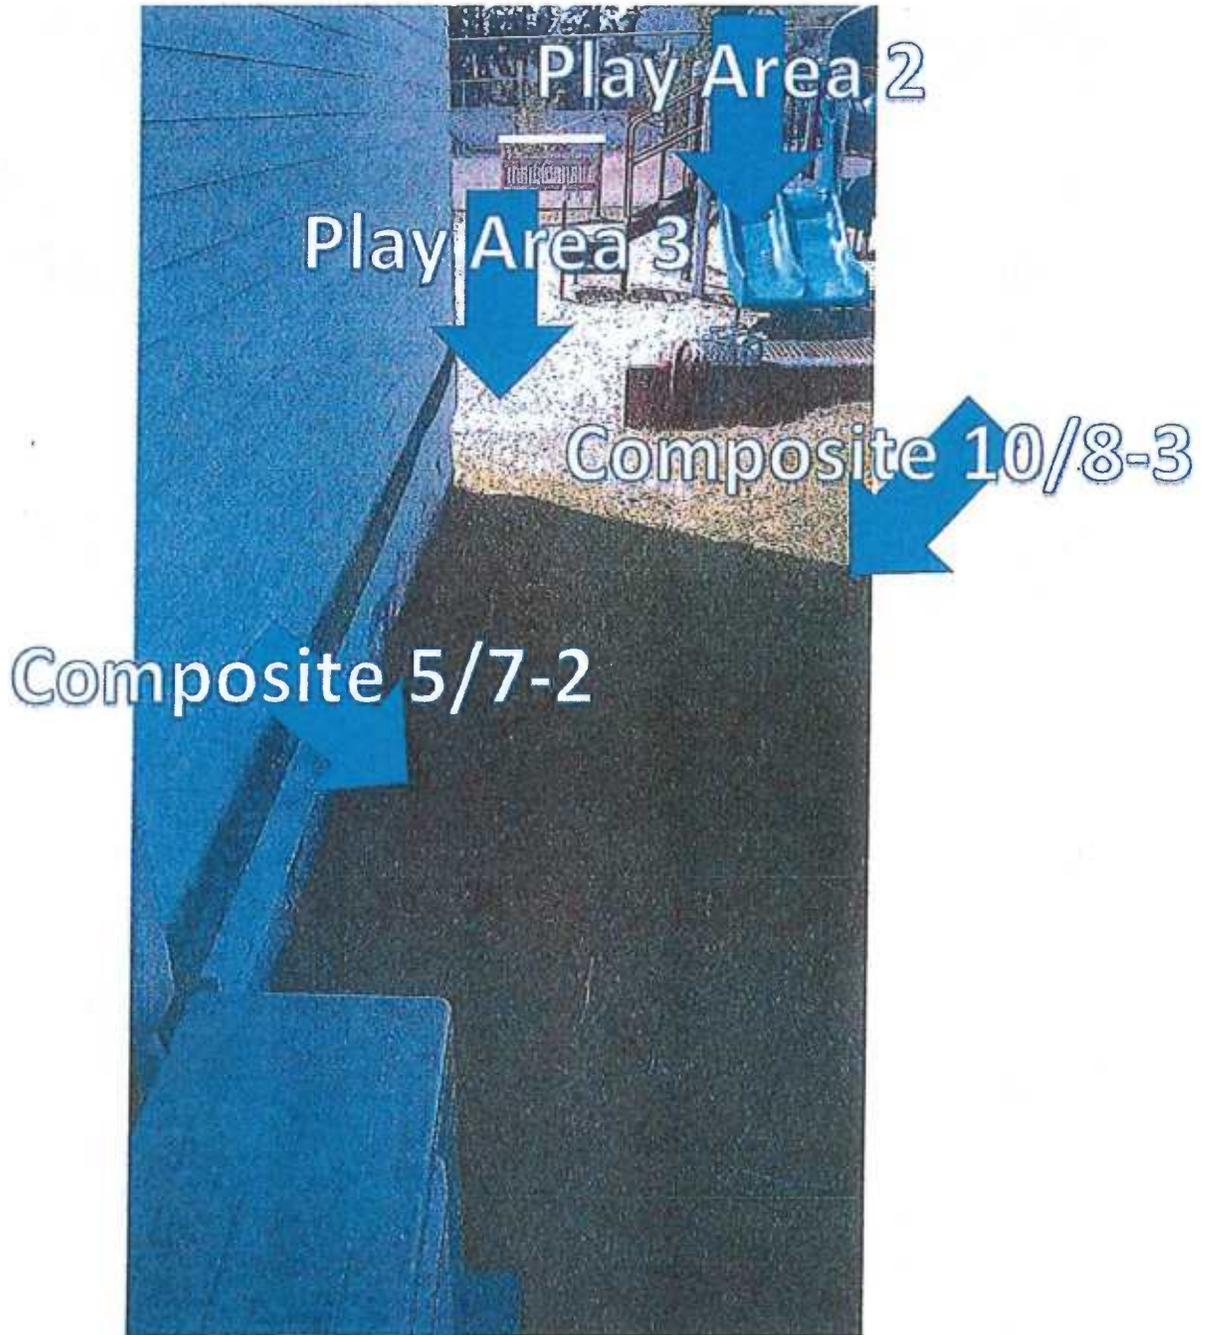
West side of building looking to the south. Play Areas 2 and 3 in the rear, Composite 2 to the far Left, Composite 3 in grassy area to the right.

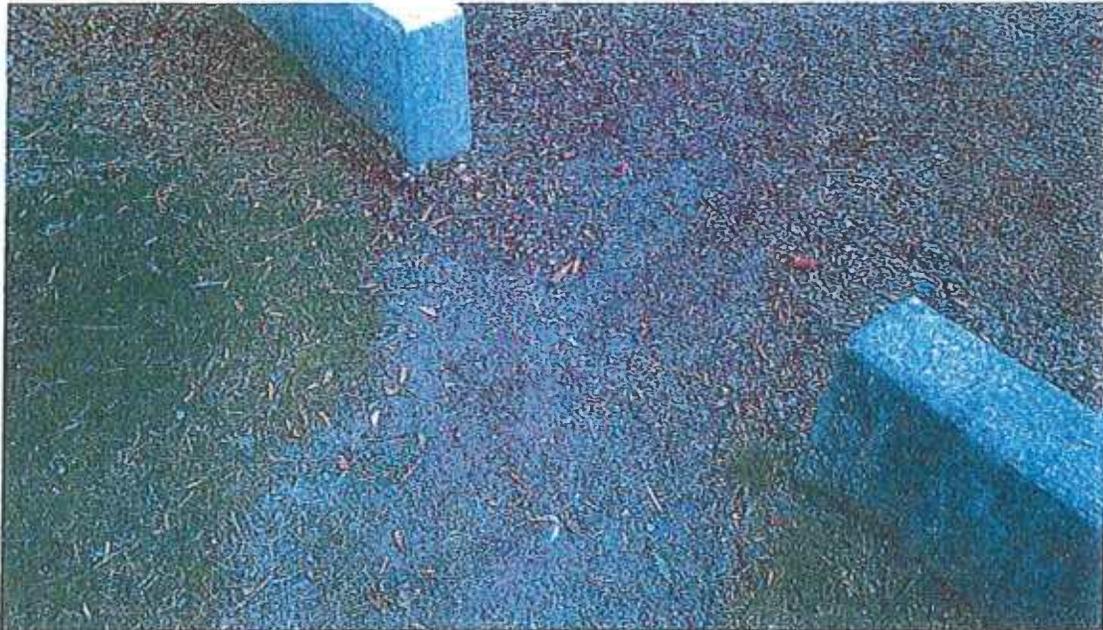
Laboratory analytical data reported that the concentration of the composite soil samples from two samples, Play Area 3 and the North and East Sides of the Building, had lead concentrations that exceed the Washington state criteria of 250 mg/Kg for lead in soil of children occupied facilities. The remaining samples fell below this criteria.

Bare Soil of Play Area 3

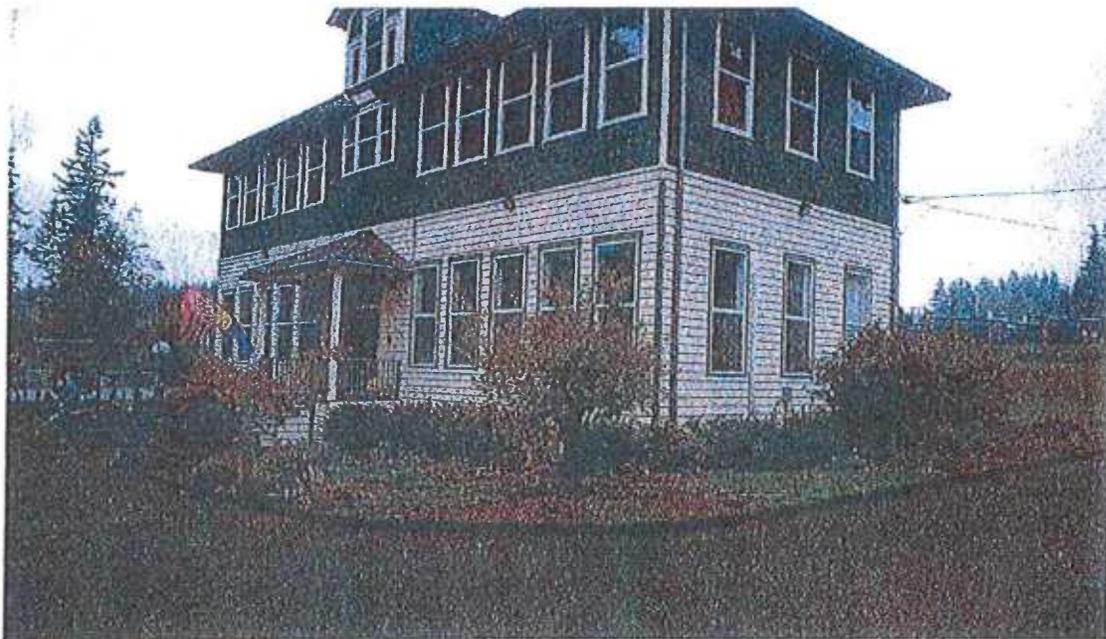
East (Front) Side and North Side of Building with Landscaping

The entire east and north sides of the building (areas where children are not expected to be playing) do not have to be remediated so long as children do not play in these areas. However, if any excavations or soil disturbing activities are conducted in these soils in the future, we recommend removing the top 6 inches of soil prior to commencing work. The estimated quantity of soil to be removed would depend on the proposed scope of work.
